Manhole Inspection Summary

Manhole # S31G__010MH

Insp Date: **10/27/08 3:02 PM**

Location Address: **149 baltimore st**

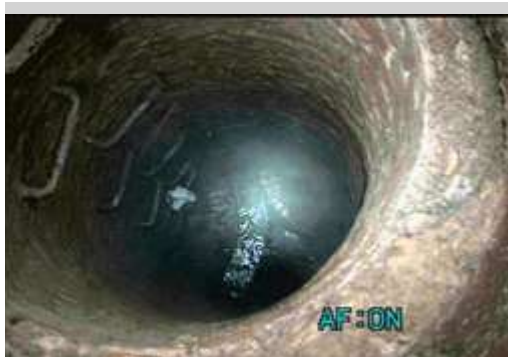
Defect 5

Infiltration: ☐ None ☐ Joint ☐ Cracks ☐ Mortar ☐ Roots ☒ **Wall**

☒ **Evidence Of Surcharge** Depth: **5** (ft.) ☐ Active Surcharge Present

barrel flow wall; surcharge evidence

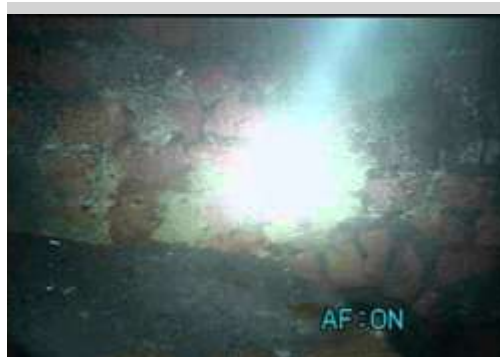
Defect 4

Condition: ☐ Sound ☐ Cracked ☐ Root Intrusion ☐ Deteriorated ☐ Leaks ☒ **Debris**

BENCH COND DEBRIS

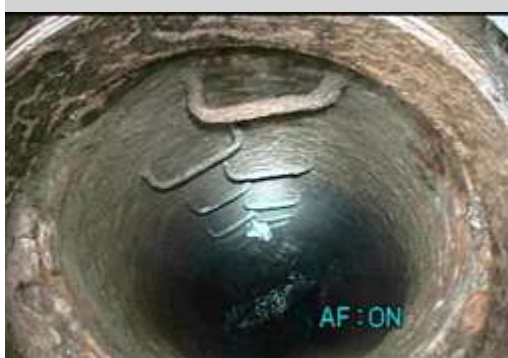
Defect 3

Count: **11** Missing: **0** ☒ **Corroded**

corr steps

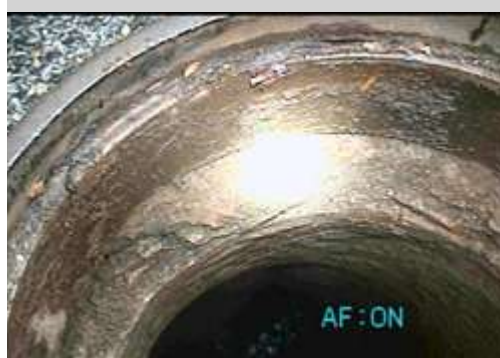
Defect 2

Offset: **4** (in.)

Condition: ☐ Sound ☒ **Cracked** ☐ Leaks

offset , frame cracked

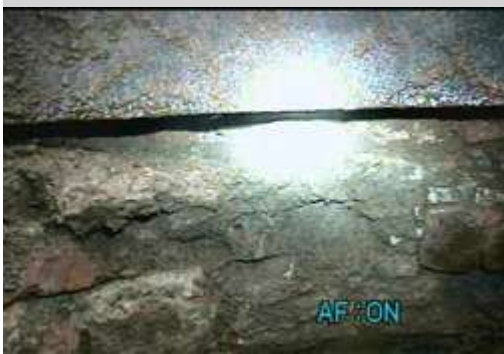
Defect 1

Condition: ☐ Sound ☐ Cracked ☐ Root Intrusion ☒ **Loose Brick** ☒ **Deteriorated**

CHIMNEY COND DETERIORATED,
CHIMNEY COND LOOSE BRICKS
